[Bureau Of Community Environmental Health](#) > [Indoor-Air](#) > [Drywall](#) > [Inspections](#)

**Self-Assessment Guide for signs that a home may be affected by drywall Associated Corrosion.**

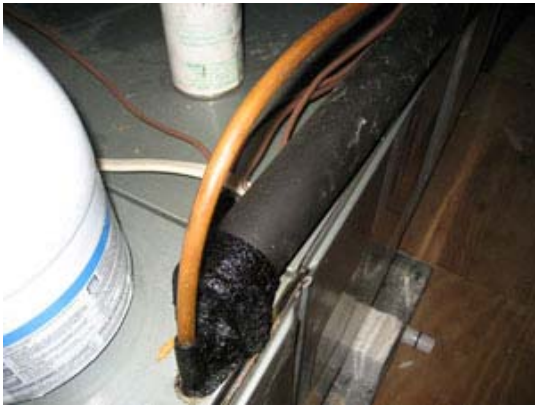
Look to see if the compressed refrigerant line going into the air handler has a black appearance, typical of sulfur corrosion. This copper line is approximately ¼ inch in diameter and can be easily viewed without opening the air handling unit (AHU) or removing any panels. If the air handler is in an interior closet or in the garage, go to it and look at the un-insulated copper line going into the air handler. Compare it to the images below. The image on the left shows the normal copper [color](#) which changes with age and normal exposure to the environment. The image on the right shows the blackening copper corrosion that is typically caused by exposure to corrosive sulfide gasses.

**Normal Copper Color**

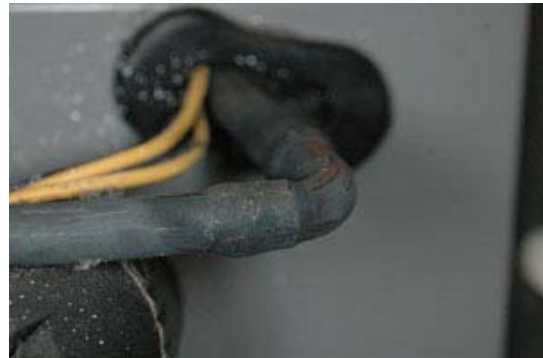
**Sulfide Corroded**

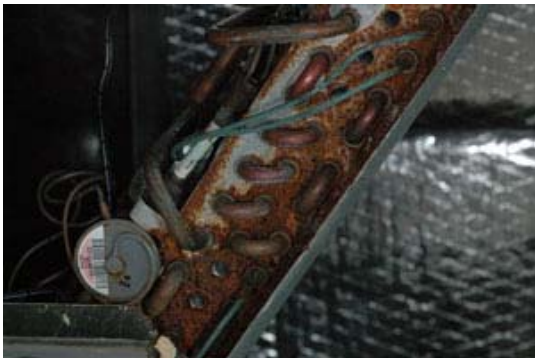
Normal copper in a rusty steel frame

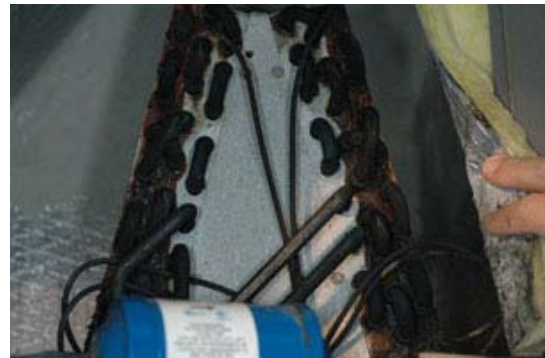
It is less likely to find the blackened copper corrosion on the un-insulated refrigerant line in homes with corrosive drywall when the air handler is located in the attic or crawlspace. We recommend you have a state licensed air conditioning contractor evaluate copper corrosion on the coils inside these units. You may also have a contractor evaluate the coils for copper corrosion when the air handler is in a closet or garage.

Sulfide corroded coil

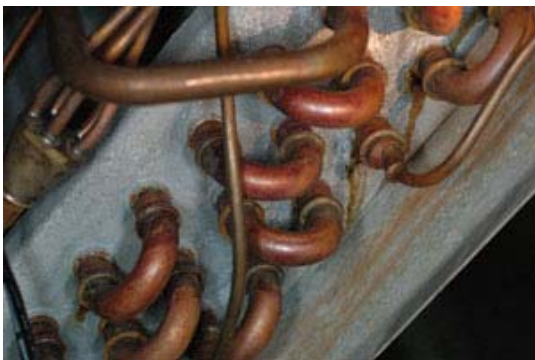
Normal copper tubing

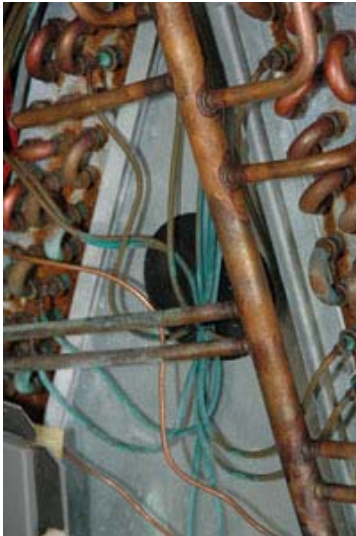
**Normal copper tubing**

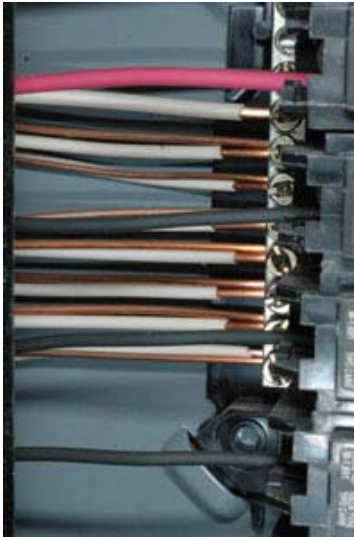
Normal wiring

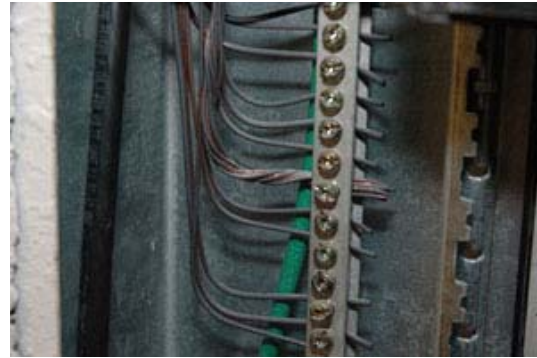
Electrical wiring as well as other copper, silver and metal fixtures may exhibit sulfide corrosion when exposed to the reduced sulfur gases. Most of the following items may be examined by the homeowner. Due to the electrical shock hazard presented by live wires, we recommend you hire a licensed electrician to inspect electrical system components.

Black corrosion on wiring

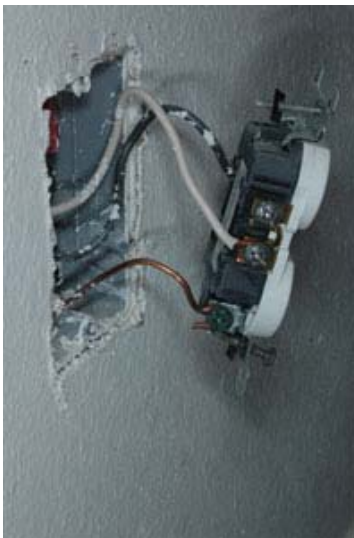
Normal outlet

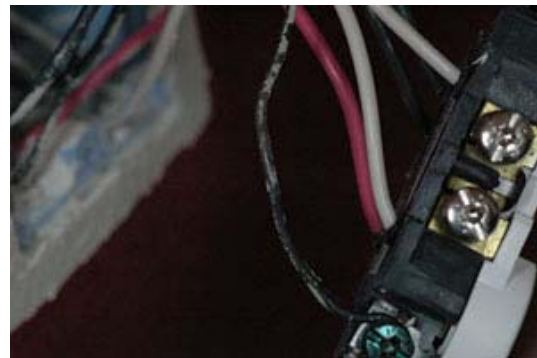
Black corrosion on wiring

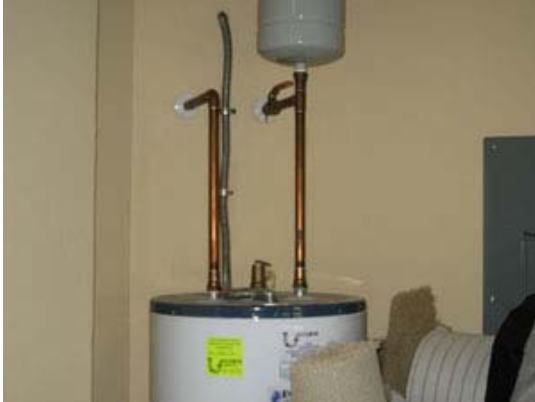
Normal copper plumbing

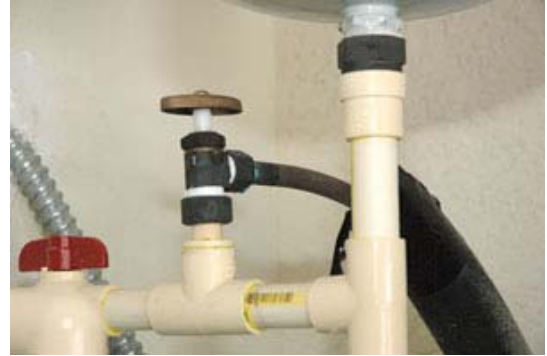
Corroded copper plumbing

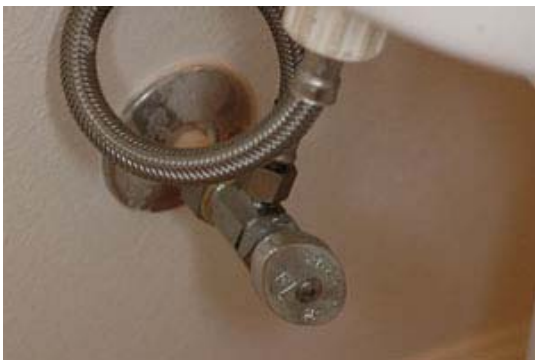
Normal shut off valve

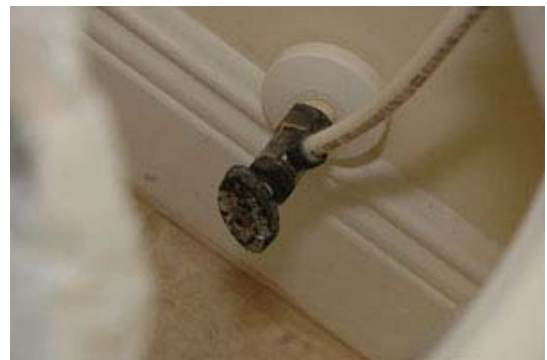
Corroded shut off valve
